Jurnal
Pensil

THE PERFORMANCE OF MASONRY BRICK WITH CALCIUM HYDROXIDE AS MORTAR

This study aims to determine the shear strength and flexural strength of red brick masonry, determine the effective thickness of calcium hydroxide mortar with a mixture ratio of 1Kp:2Ps, and determine the failure pattern of red brick masonry due to the load received during the direct shear strength test and flexural strength test. The research was conducted by experimental method. The tests carried out were the direct shear and flexural strength tests. Variation of successive mortar thickness of 10mm, 15mm, and 20mm. The test object is 18 (eighteen), the thickness variation consists of 3 test objects. Data analysis used descriptive quantitative by finding the average value of the shear strength and flexural strength. Based on the test results, the average compressive strength and splitting tensile strength of the mortar were 0.613 MPa, 0.0414 MPa. The average shear strength with a 10mm; 15mm; and 20mm is 0.025 MPa; 0.020 MPa; and 0.016 MPa, respectively. The flexural strength of mortar thickness with 10mm, 15mm, and 20mm are 0.034 MPa; 0.045 MPa; and 0.041 MPa, , respectively. In the masonry shear tes

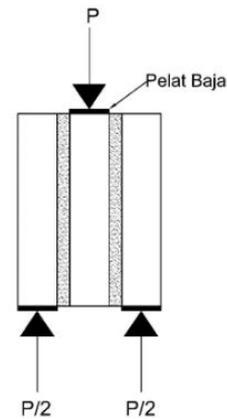
Figure 1. Direct test (Istegun & Celebi, 2018)

Testing the shear strength of the masonry was carried out using triplet

specimens with a testing mechanism as shown in Figure 1.

The shear stress of masonry can be calculated using Equation (4)(SNI-03-4164, 1996).

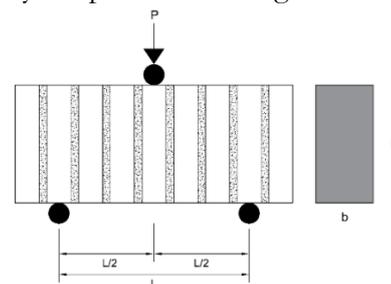
Figure 2. Flexural test (SNI 4154, 2014)

The flexural strength test of the masonry was carried out using the three-point bending method. The location of the test object, the supports, and the loading points for the flexural strength test of the masonry are presented in Figure 2.

The flexural strength of masonry can be calculated using Equation (5).

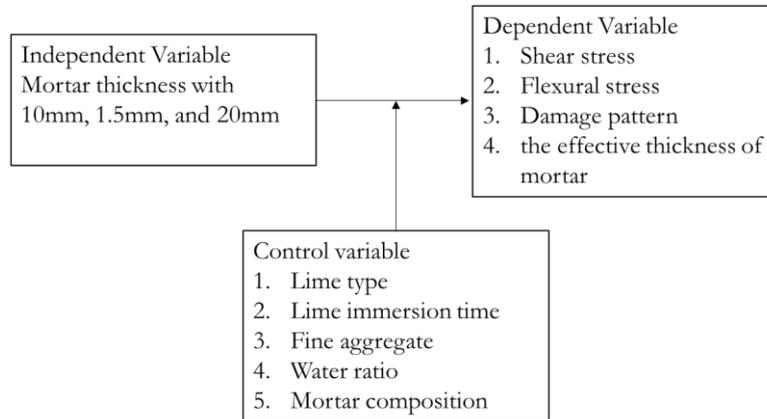
Figure 3. Reseach variable

The brick masonry test specimens in this study were made using quenched lime mortar based on the most optimum compressive and splitting strength values and with a variation of mortar thickness of 1 cm,

15mm, and 2mm. The use of thickness variations aims to obtain the most optimal mortar thickness for red masonry with lime mortar. Figure 4 shows the relationship between variables.

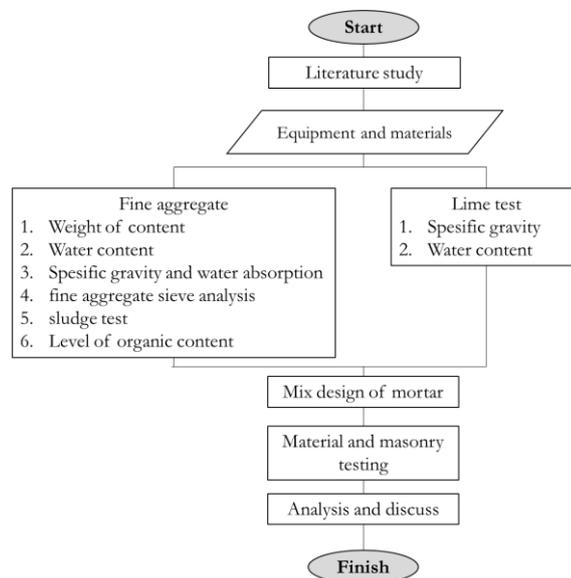
Figure 4. Research flow

The independent variable in this study is the thickness of the mortar layer on the brick masonry, with the direct shear and flexure test scheme on the specimen. Each

composition value is determined by mixing quicklime and fine aggregate. The research was carried out in stages as shown in Figure 5.

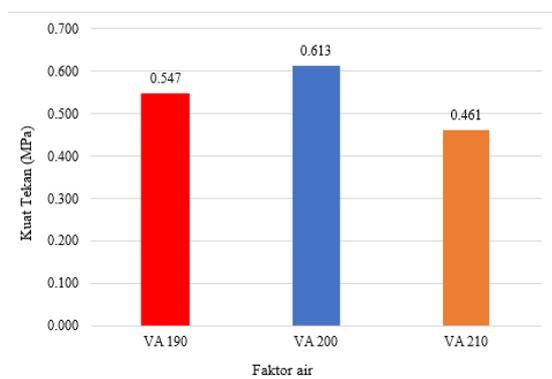
Figure 5. Compressive strength averages

Based on Table 1 and Figure 5, it can be seen that the mortar test object with lime immersion water variations is 1.9; 2.0; and 2.1 produces a strong compressive strength of 0.547 MPa, respectively; 0.613 MPa; and 0.461 MPa. The lowest average compressive strength of mortar is in the water variation 1.9. The most optimal average cube mortar compressive strength is in the water variation 2.0. The results of this study have higher compressive strength and split tensile strength values compared to research (Murty, 2005), which has relatively smaller compressive strength due to the manual-based material mixing process.

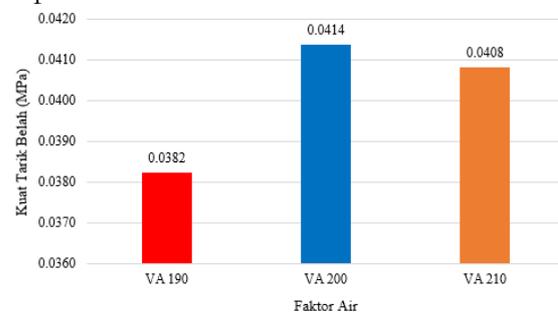
Figure 6. Splitting tensile strength averages

Based on Table 2 and Figure 6, it can be seen that the mortar test object with variations in lime soaking water is 1.9; 2.0; and 2.1 produces a split tensile strength of 0.0382 MPa each; 0.0414 MPa; and 0.0408 MPa so that the most optimal is the water variation 2.0.

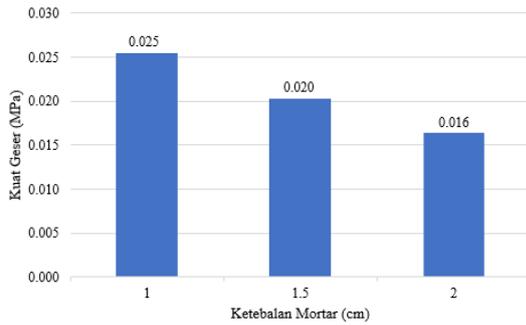
Figure 7. Direct shear test averages

Based on Table 3 and Figure 7, the results of comparing the average shear strength of the masonry for each variation of mortar thickness are 0.025 MPa, 0.020 MPa, and 0.016 MPa. The highest average shear strength occurred in the mortar with a thickness of 1 cm, which was 20.10% greater than the 1.5 cm mortar variant and 35.21% greater than the 2 cm mortar variant. The lowest average shear strength occurred in the 2 cm mortar variant, 18.92% lower than the 1.5 cm mortar variant. The shear strength of the red masonry with a mortar thickness of 1 cm has a higher value than the thickness of the other mortar variants. This is due to the

shrinkage properties of the quenched lime material on the brick masonry, affecting the mechanical behavior when a direct shear test occurs. The bonding capacity of quenched lime still needs to be done with a longer age approach, also by adding other additives, namely silica fume material, to increase its shear strength. The thicker the mortar layer, the more brittle it will be and has a small shear value, in addition to the nature of the quenched lime as a pozzolan which takes longer to react with water.

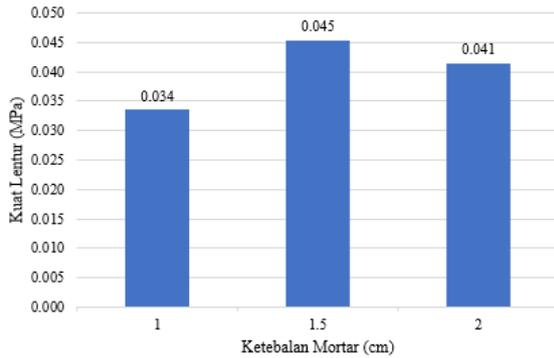
Figure 8. Flexural test averages

Based on Table 4 and Figure 8, the comparison results of the average flexural strength of the masonry for each variation of mortar thickness are 0.034 MPa, 0.045 MPa, and 0.041 MPa. Flexural strength with the highest value occurred in the mortar with a thickness of 1.5 cm, which was 25.84% greater than the 1 cm mortar and 8.91% greater than the 2 cm mortar variant. Red brick's lowest average flexural strength occurred in the 1 cm mortar variant, 18.58% lower than the 2 cm mortar variant. This is due to the sticky power of the extinguished lime, which will be brittle if it has larger dimensions. In addition, its higher shrinkage will impact its mechanical characteristics; a faster drying process in this masonry requires stable moisture to maintain the properties of quenched lime, which requires longer react with other connecting components (Lumantarna et al., 2012; Pozo-Antonio, 2015; X. Zhang et al., 2023).

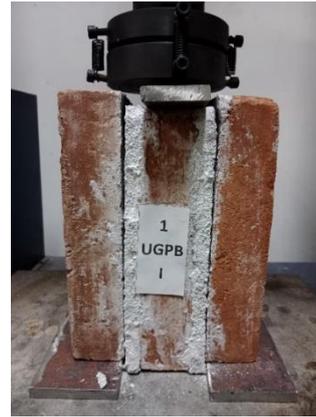
Figure 9. Failure pattern of 1 UGPB

The masonry suffers type A damage, namely the bond failure between the mortar and the masonry (slip) with a 100-mm, 150-mm, 200-mm in thickness.

The damage that occurred to the specimens with various mortar thicknesses had similar characteristics, this was because the slaked lime had a longer setting time due to its pozzolanic nature. There is a slip failure at the interface due to the imperfect bonding process, improper installation conditions, and smooth brick surface conditions.

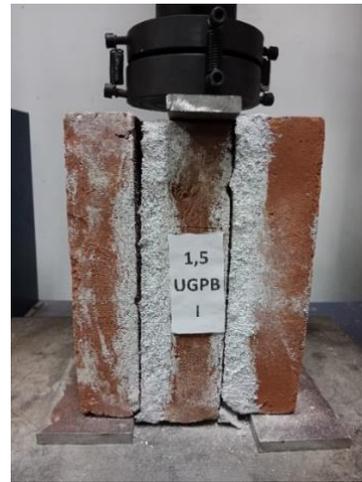
Figure 10. Failure pattern of 1.5 UGPB

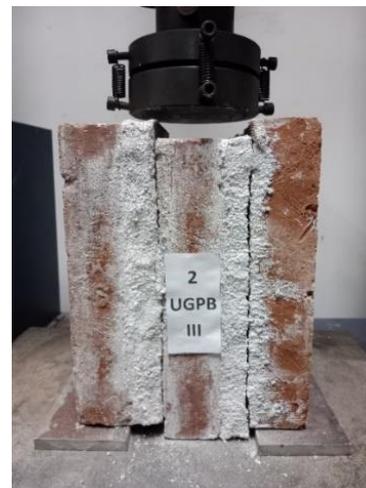
Figure 11. Failure pattern of 2 UGPB

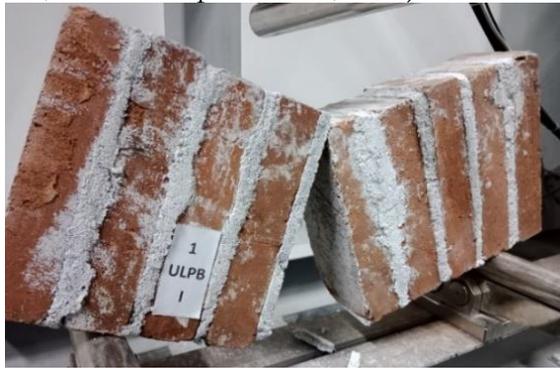
Figure 12. Failure pattern 1 ULPB

Each specimen with a thickness of 10 mm has a type A failure pattern, namely the failure of the mortar at one brick-mortar interface.

Various patterns of brick masonry failure are presented in Figures 12 to Figure 1. Each test characteristic has similar failures. This indicates that the quenched lime mortar has a special effect on the variety of failure patterns in masonry (Bompa & Elghazouli, 2020; Chase, 1983; Elghazouli et al., 2021; Gil, 2016; Sathiparan et al., 2013).

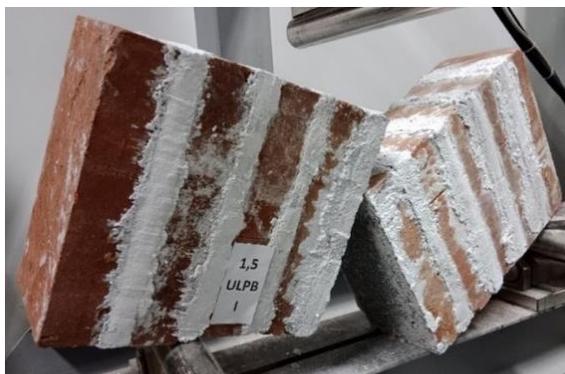
Figure 13. Failure pattern 1.5 ULPB

Each specimen with a thickness of 15mm has a type A failure pattern, namely

the failure of the mortar at one brick-mortar interface.

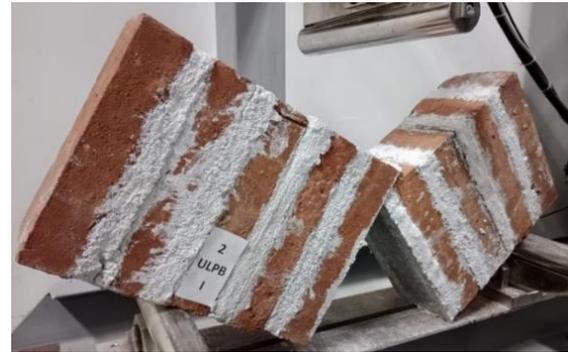
Figure 14. Failure pattern 2 ULPB

Each specimen with a thickness of 2 cm has a type A failure pattern, namely the failure of the mortar at one brick-mortar interface. It can be concluded that all ULPB specimens failed in the mortar because the bonds produced by the mortar and the bricks were smaller than the bonds between the mortar and the mortar.
